Subject: Stoney Creek Flood Plain
Field Observation and Guidance
Woodlands Subdivision, Concord, North Carolina

Existing Flood Plain Mapping

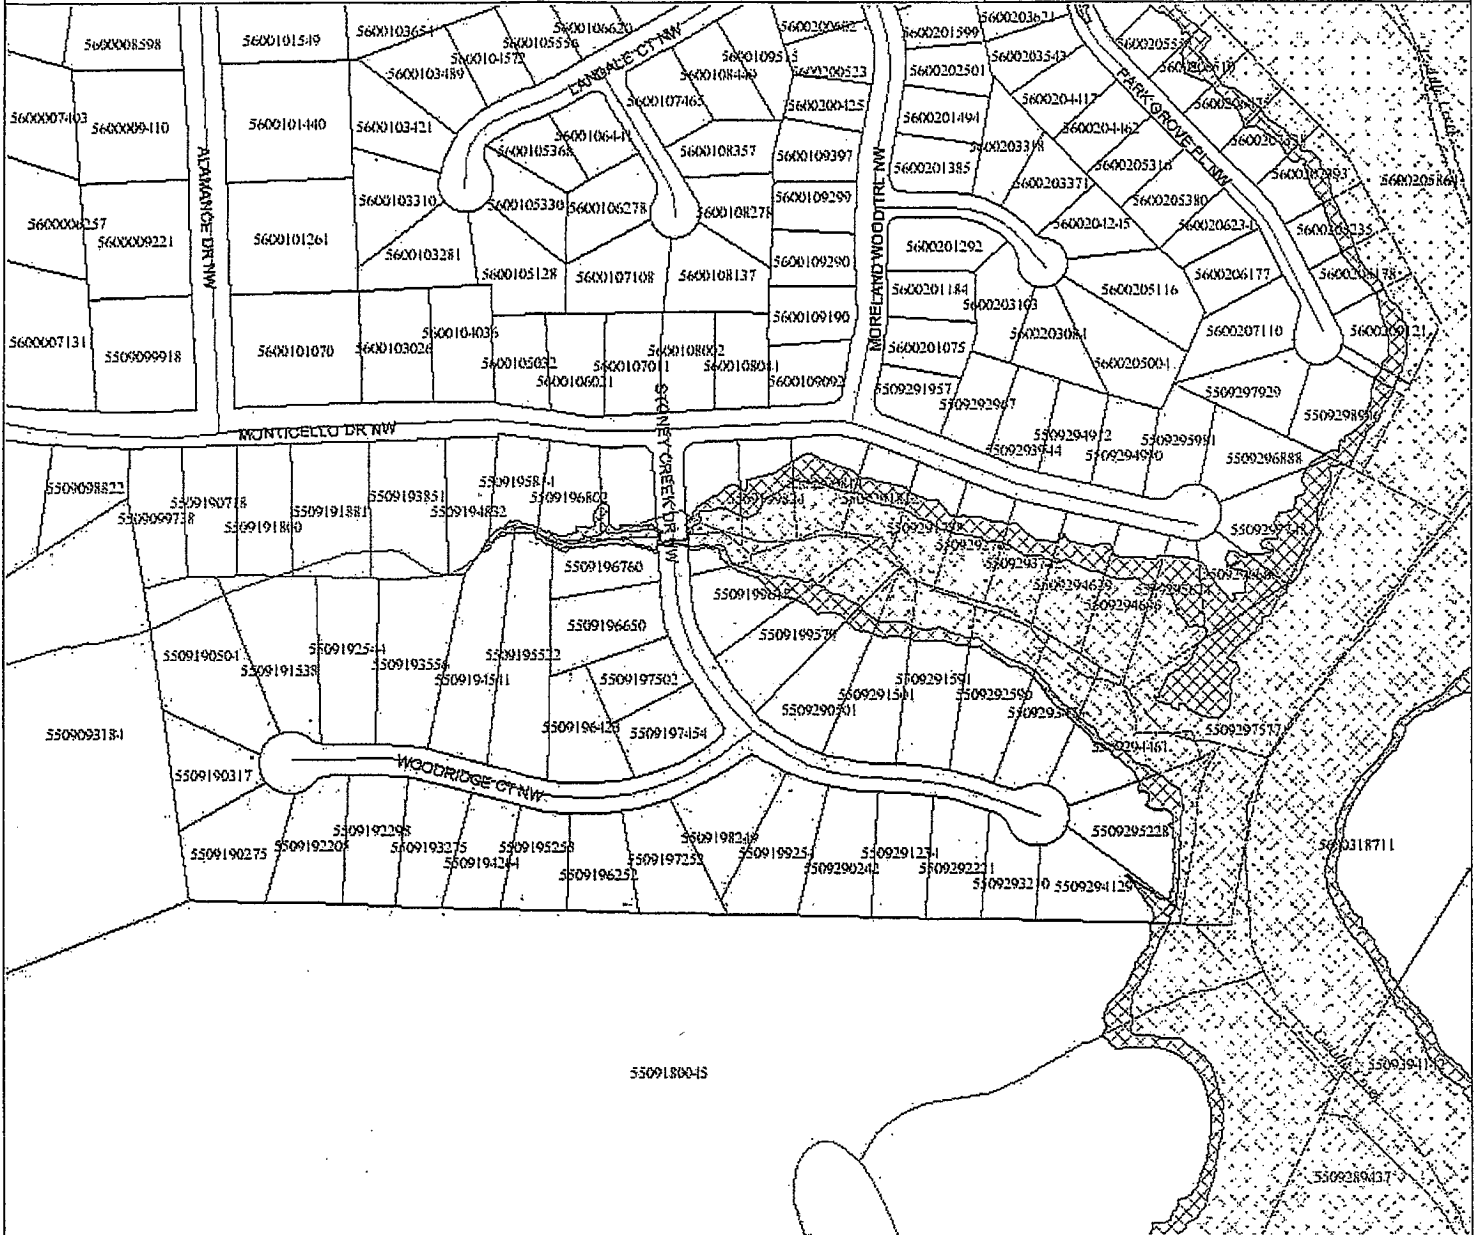
Map Printed On August 13, 2009

Comments Woodlands Subdivision

Within the last year, Cabarrus County has adopted revised flood plain mapping. The current mapping shows a substantial flood plain extending up to and slightly past Stoney Creek Drive NW where a double barrel culvert with head walls is located. The flood plain extends to the confluence of Stoney Creek and Coddle Creek. Please refer to the flood plain maps attached as exhibits at the end of this document. It is clear from the flood plain mapping that the majority of the property along this reach of the creek are impacted by flood plain to different degrees. During peak storm events a major portion of the rear yards are within the subject flows. Many homes maybe required based on elevation and location to carry flood insurance.

Overall Stoney Creek is in good condition, some minor maintenance items can be undertaken to slightly better its overall condition as noted above. However, even these measures will only make the flood plain act as shown on the exhibits attached. The flood plain can not be eliminated from these properties and very little can be done to lower that flood plain within existing regulations by altering Stoney Creek. The best scheme going forward is to keep the creek channel maintained and understand what the impacts of development are to the flood plain. CESI hopes this report has been helpful and please do hesitate to contact us should you need additional information or have questions.
